**THE SPAB RESEARCH REPORT 1.**  
**U-VALUE REPORT**  
**REVISED OCTOBER 2011.**

Dr Caroline Rye

This report was first published in October 2010, this is the revised edition published in October 2011.

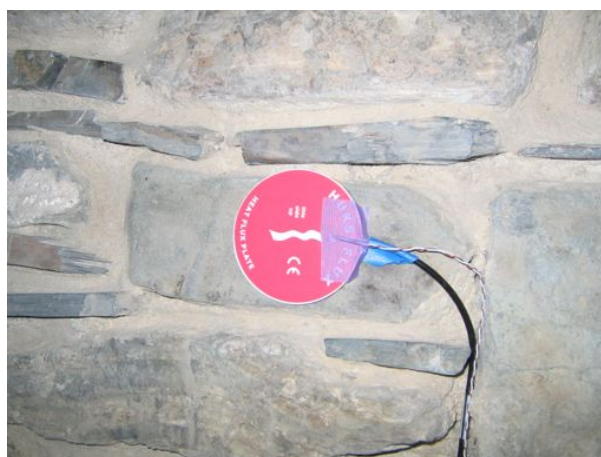
A Hukseflux HFP01 heat flux sensor is attached to the interior surface of the wall under investigation (Figure 1). The sensors are 80mm in diameter and 5mm thick. The sensors were mounted by firstly applying a layer of double-sided adhesive tape to the back of the sensor. Secondly, low tack masking tape was applied to the wall. Finally, the heat flux sensor was applied firmly to the masked area. This arrangement was generally satisfactory for two or more weeks monitoring on painted or plastered surfaces. Wallpapered surfaces were not generally used in case of damage. On occasion, if a wall surface was uneven, such as a bare stone or limewashed rubble wall, it was necessary to attach the sensors using a small quantity of silicon sealant.

Fig. 1. Heat Flux Sensor and surface temperature thermocouple.

thermographic camera was used to survey the internal face of the wall to ensure a general uniformity of surface temperature and thus establish a representative site for the placement of the sensor (Figure 2). The heat flux data was logged on a Campbell Scientific CR1000 data logger. The Campbell data logger also recorded the surface temperature of the same wall using a type-T thermocouple taped onto the surface of the heat flux sensor (Figure 1).

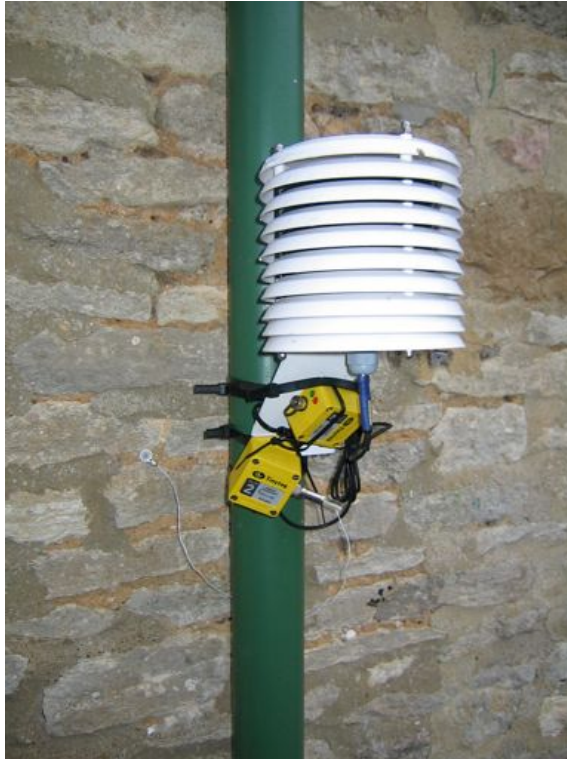
External temperatures were measured using a separate Gemini TinyTag Plus 2 TGP-4520 data logger which could be mounted outdoors. Thermistor probes were used to measure external air temperature and, generally, external wall surface temperature. Each external air temperature sensor was placed in a radiation shield which was secured, for example, onto a drainpipe (Figure 3). Crimp-on terminals were used to fix surface temperature sensors to mortar joints, by drilling and plugging joints. Figure 3 shows the method of mounting external surface temperature sensors. In some cases external surface temperature sensors were not used either to avoid damaging the exterior surface of the building, for example, a rendered finish, or owing to difficult access.

Fig. 3. Air and surface temperature sensors.

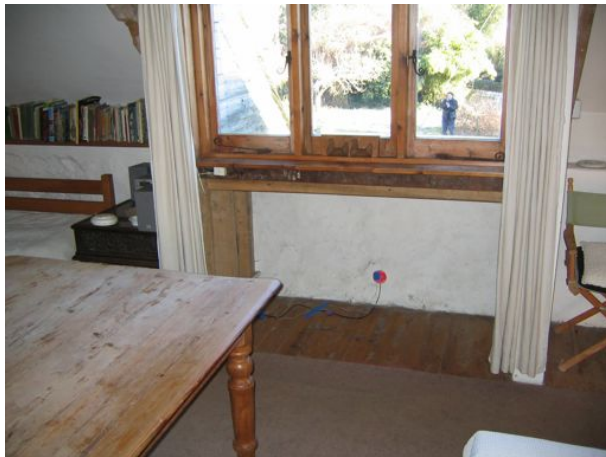
There are three *in situ* U-value results which are widely divergent from those measured on similar materials in the study. The U-value of  $0.76 \text{ W/m}^2\text{K}$  for a 615mm thick granite wall recorded at Higher Uppacott (5c) seems extremely low. Conversely, the value  $2.26 \text{ W/m}^2\text{K}$  for a 510mm cob wall recorded at Oxenholm Farm (7b) seems high and at this location there is the possibility of thermal bridging affecting the final result due to poor sensor placement in close proximity to an intermediate floor (Figure 5). Example 9b from a house in Farrington in Oxfordshire gives a figure of  $1.05 \text{ W/m}^2\text{K}$  for a limestone rubble wall. When plotted against similar wall types this figure does not conform to an overall trend and therefore may possibly be treated as an outlier or is the result of a high proportion of mortar and voids within that particular wall construction (Figure 6).

Fig. 5. Cob sensor placement at Oxenholm Farm (7b).

Previously it had been thought that the figure from 7b Oxenholm ( $2.26 \text{ W/m}^2\text{K}$  @ 510mm) was questionable due to possible sensor placement error (see page 12.). Subsequently, more *in situ* U-value data has been gathered for cob walls, both earth and chalk, and this would seem to confirm the 7b Oxenholm U-value as erroneous (Fig. 9).

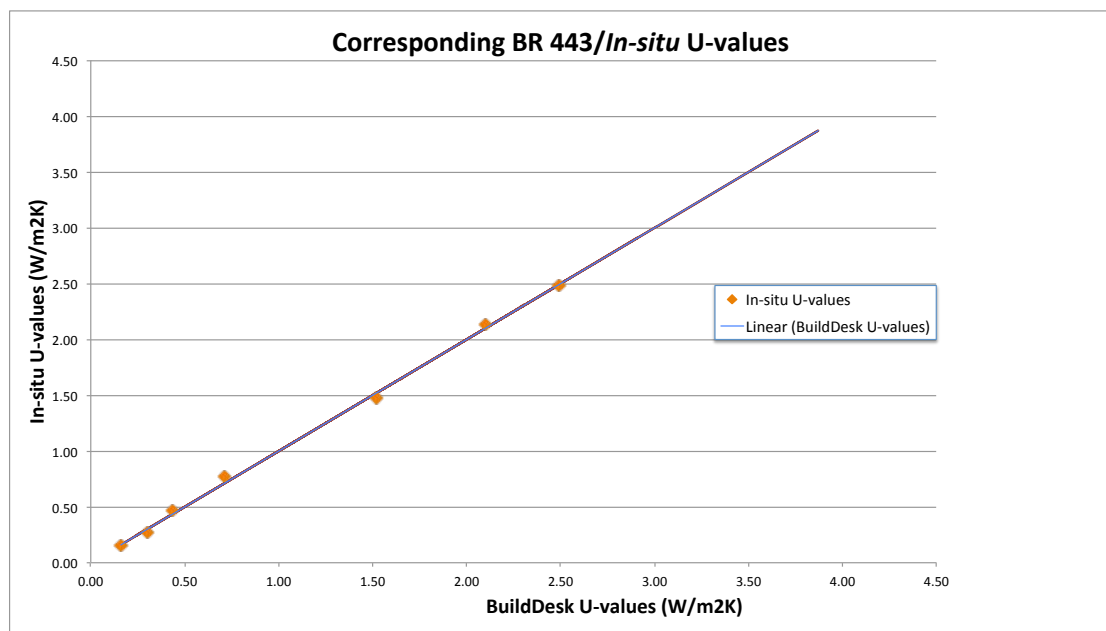
The closest correspondences between the BuildDesk figures and the *in situ* U-values occurred when calculating walls consisting of well defined and simple build ups where the thermal conductivity value of the material being calculated was also well established (Fig. 19.). This was the case for seven walls within the study detailed in Table 3.

Figure 19. BuildDesk/*in situ* U-value correspondence.

The majority of these examples, 1c, 1h, 11a and 24c are from timber-frame walls. The nature of timber-frame wall constructions consisting often of only a single thin layer within a stud framework mean that the materials and proportions involved in these build ups are clear and thus simpler to define for the purposes of performing a U-value calculation. These constructions also correspond, by chance, with discrete, layered methods of construction which are the basis of much modern construction techniques, a method that the software was original design to quantify using a summing of the different material resistances found within a layered build up. These features are in marked contrast to an existing stone wall where, although the overall thickness of the element may be known the different proportions of materials involved in its construction, including mortar, and the random nature of their amalgamation defy accurate description.
